Readjust Hood Latch

Classification	Campaign Bulletin	Section/Group	11 - Closures	Country/Region	United States, Canada
Year	2018	Model	Model 3	Version	All

On certain Model 3 vehicles, the hood latch might be out of alignment, causing a possible interference with the underhood storage unit.

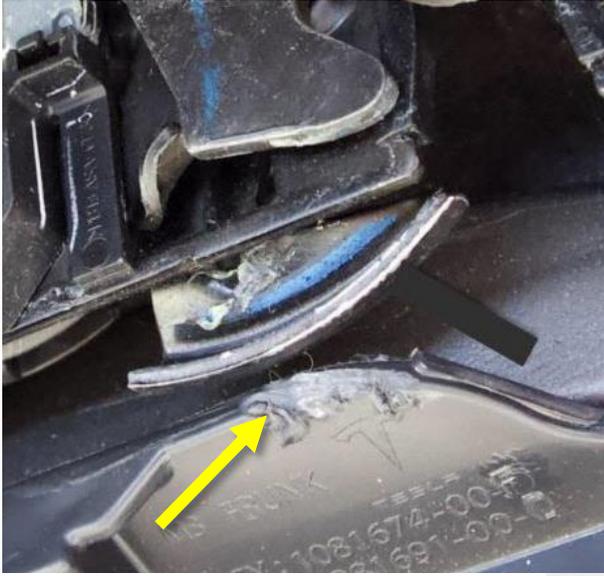
1. Remove the hood latch cover (refer to Service Manual procedure 15241102).
2. Inspect the underhood storage unit near the hood latch:
 - If the underhood storage unit is damaged from contacting the hood latch striker (Figure 1), continue to the next step.
 - If no damage is found on the underhood storage unit (Figure 2), skip to step 5.

Figure 1 (Underhood storage unit damaged)

3. Draw a line on the underhood storage unit approximately 11.5 mm from the edge of the latch cutout (Figure 3), and then draw a line perpendicular right next to the curved feature (Figure 4)

4. Cut out and discard the marked sections of the underhood storage unit between the lines using diagonal cutters or similar tool (Figure 5).

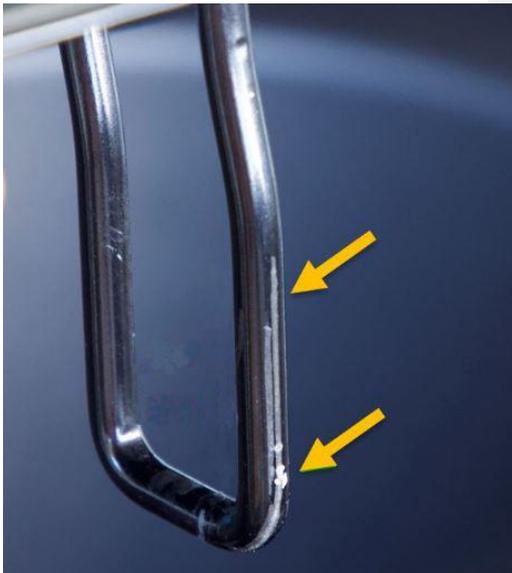
- If scrape marks are found at the front of the hood latch striker (Figures 6), continue to step 14.
- If no scrape marks are found at the front of the hood latch striker (Figure 7), continue to the next step.

✗ Figure 6 (Visible scrape marks at the front of the hood latch striker)

14. Remove the bolts (x2) that attach the hood latch to the front end carrier (Figure 14).

15. Position 2 shims between the hood latch and the front end carrier (Figure 15), and then hand-tighten the LH hood latch bolt to the front end carrier. Repeat this step on the RH hood latch bolt.

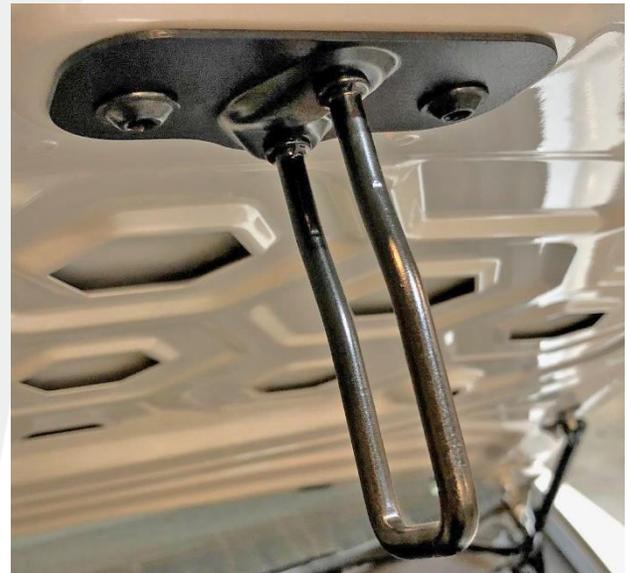
✓ Figure 7 (No scrape marks at the front of the hood latch striker)

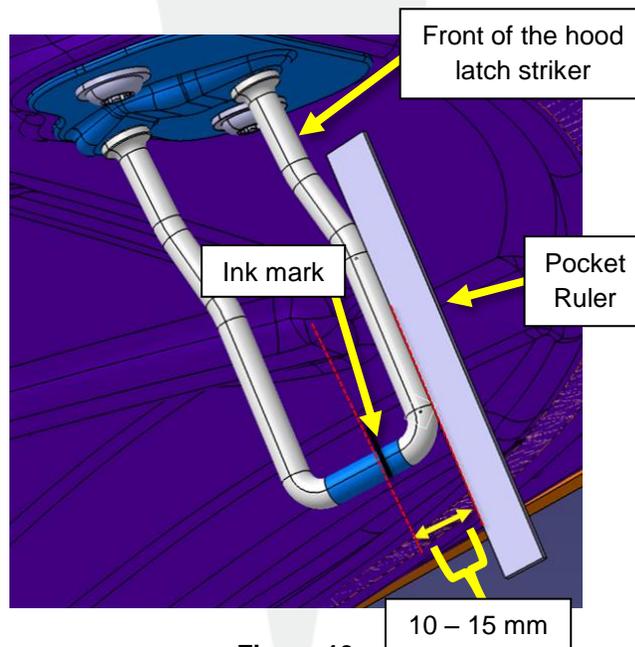
Figure 13

13. Measure the distance between the front of the hood latch striker and the ink mark left by the latch point on the hood latch using a pocket ruler and a digital caliper or ruler (Figure 13):

- If the measured distance is between 10 and 15 mm, remove the masking tape from the hood latch striker, and then go to step 19.
- If the measure distance is less than 10 mm, continue to the next step.

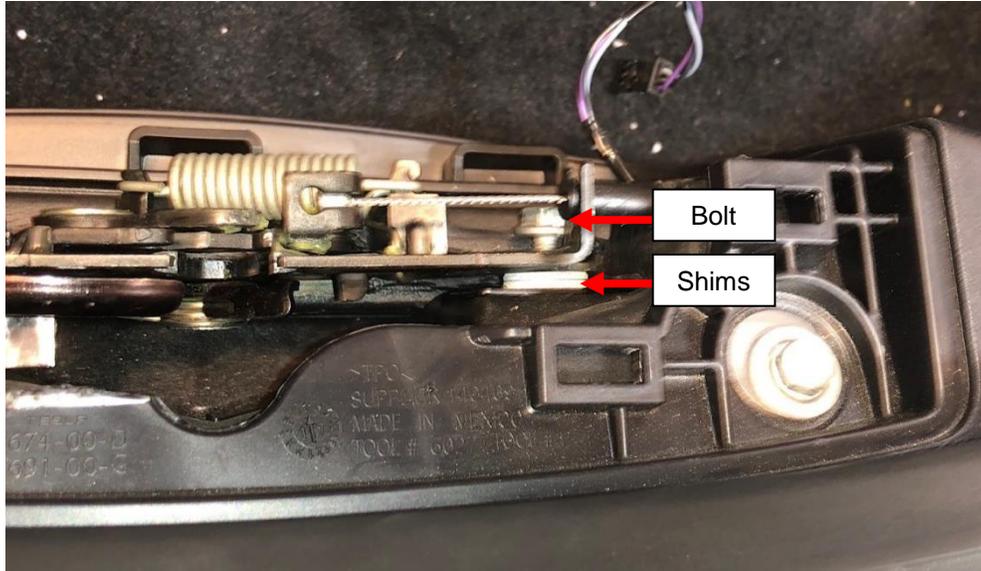
Figure 15 (LH hood latch bolt and shim, RH similar)

NOTE: Use needle-nose pliers to position the shims while installing the hood latch bolt.

16. Push the hood latch assembly down fully, and then tighten the hood latch bolts (torque 8 Nm).
